**Structural Assessment
of
Brambles Bistro, Glenluce**

Prepared by: Alan S. Johnstone B.Sc.(Hons), C.Eng., M.I.C.E.

September 2018

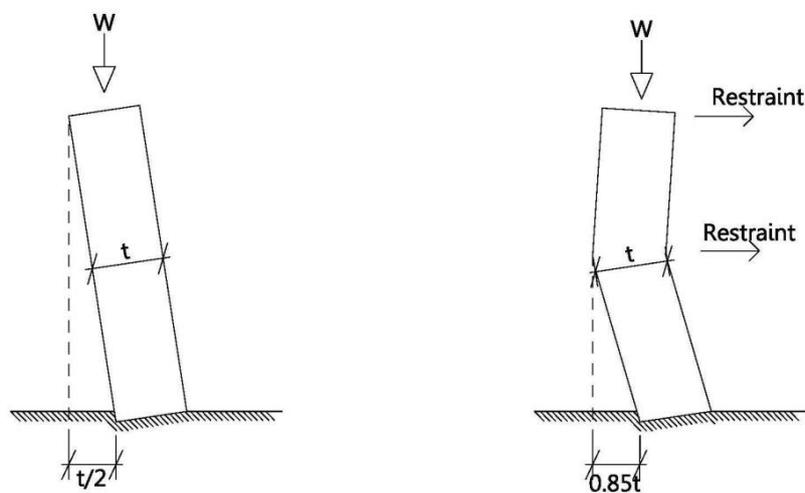
Most of the Walls throughout the building exhibit varying degrees of leaning. In accordance with the recommendations of CIRIA Report 111 (1986) an unrestrained wall supporting a concentric load (in this case the roof) reaches precarious equilibrium at 50 per cent of wall thickness. If a lateral restraint was incorporated precarious equilibrium would be reached at 85% of the wall thickness.

With the exception of the south west gable at second floor level the lean on the walls wouldn't be considered as unstable. The south west gable at second floor level is likely to exceed the $t/2$ limit and should be considered as unstable. In addition to the leaning of the walls there are other issues affecting their integrity. The ground floor walls towards the rear of the building which are below ground level are very wet and the lime mortar has disintegrated in many places. It is likely that this deterioration is present throughout the thickness of this wall. The elevation fronting Main Street exhibits an outward lean above first floor level externally but is plumb internally. The wall would have been built plumb on both faces so it is likely that the inner and outer skins of masonry appear to have delaminated.
